**DAM SAFETY INSPECTION  
REPORT**

**GORGAS STEAM PLANT  
WALKER COUNTY,  
ALABAMA**

**PROJECT NO. 09-4157  
JULY 2009**

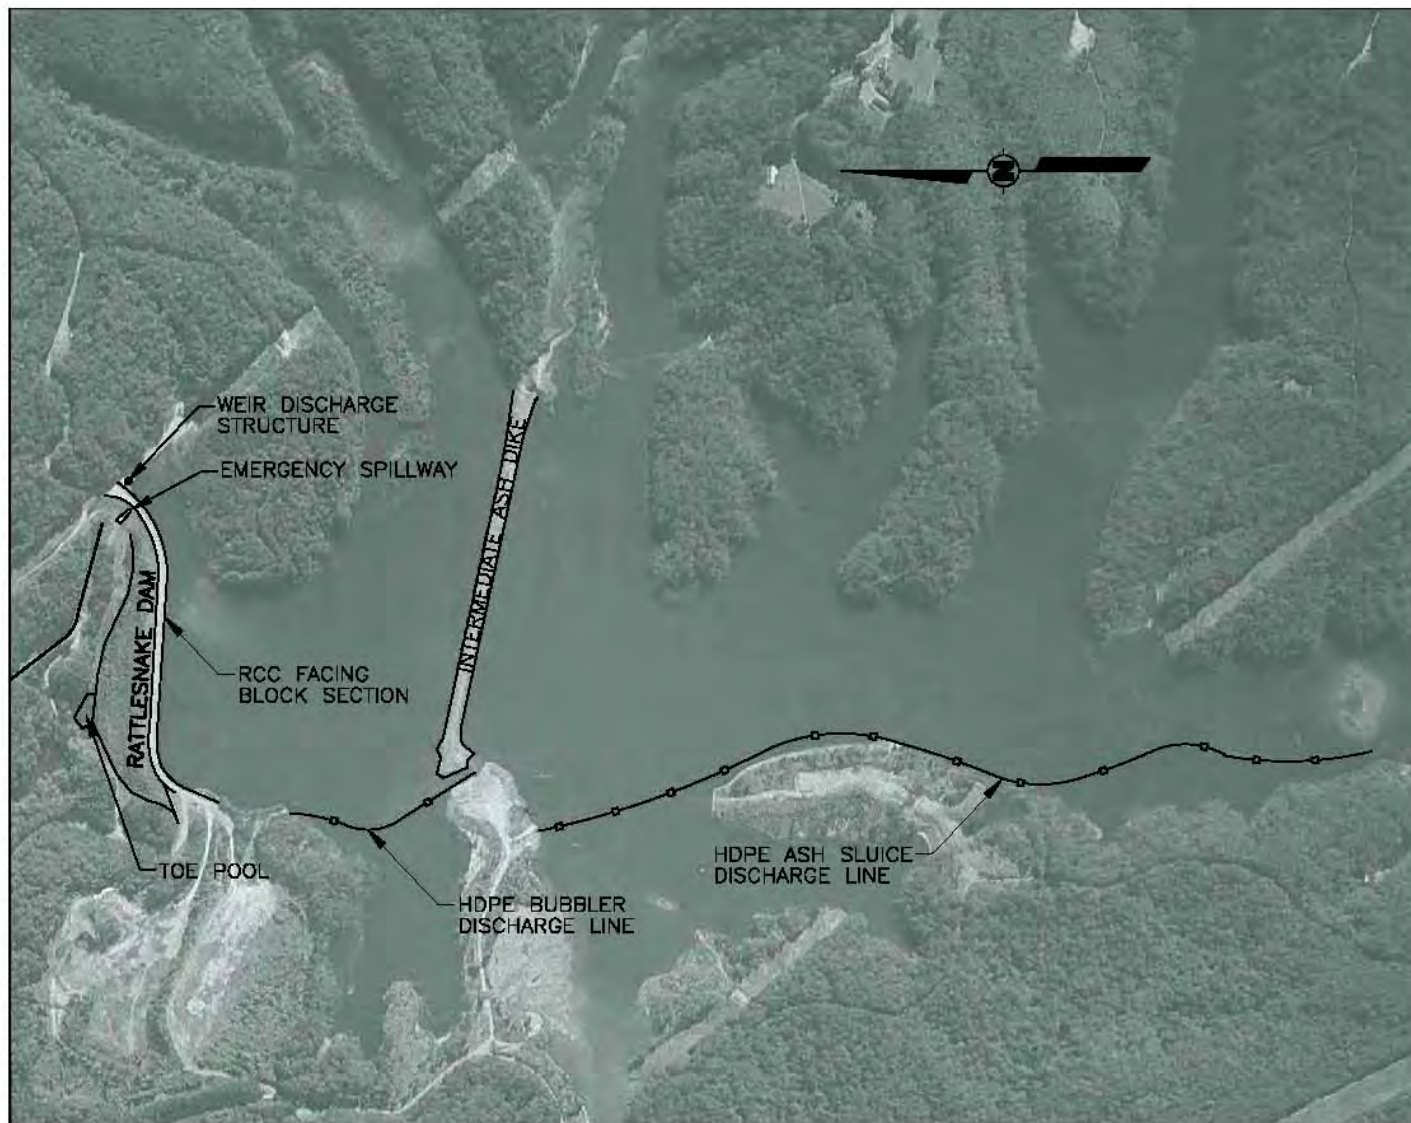
**FIGURE 2**  
 RATTLESNAKE HOLLOW  
 ASH POND AND FEATURES  
 GORGAS PLANT  
 DAM SAFETY INSPECTION  
 PREPARED FOR

- ① APPROXIMATE LOCATION OF SEEPAGE FROM TOE.
- ② CRACKING IN RCC FACING BLOCK NOTED HERE.
